# Great Neapolitan earthquake of 1857

Robert Mallet, Royal Society (Great Britain)

# **GREAT NEAPOLITAN EARTHQUAKE OF 1857.**

TO INVESTIGATE THE CIRCUMSTANCES OF THE GREAT  
EARTHQUAKE OF DECEMBER 1857.

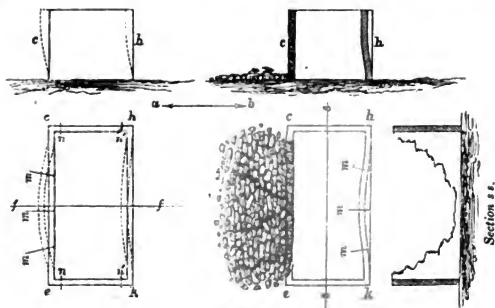
Fig. 28.

If, however, the building be rectangular, and with the sides  $ce$  and  $hk$  of considerable absolute length, and largely exceeding that of the ends, and the path of a normal wave be through them in the direction  $a \dots b$  (Fig. 28), it then

rarely happens that fissures occur, or occur alone near the quoins.

sense; and were it sufficiently rigid along its length, it might tear off from the ends, and fissures occur as before at  $n n$ ,  $n' n'$ , the other side wall  $h k$  following the movement already described for  $b$  (Figs. 21-23).

The whole length of  $c e$  has an equal velocity impressed; it is unsupported for its whole length, except at the two extremities, where it is connected by the quoins with the end walls, and held fast by them. It bends into a curve, therefore, along its length, bowing outwards most at the top and centre of length, and receiving several fractures  $m m m$ , approaching to vertical in direction, owing to the length of the curve being greater than that of the originally straight wall. The whole bond of the materials is more or less disturbed; but the force of the shock may only be such, as to thus curve and fracture, but not overthrow the wall. The wall  $h k$  in like manner is urged forward at the ends  $h$  and  $k$  by the connection with the quoins of the end walls; but failing also in rigidity, the central part is left behind, and bent also by inertia; differing from the first case analyzed in this also, that the direction of movement impressed is not in the same direction with the wave transit, but reverse to it; so that here both side walls  $c e$  and  $h k$  move alike in direction, but to different extents. The greater velocity  $V$  is common to both, for both have their velocities impressed by the first semi-vibration of the wave; and were the nature of the connection at the quoins the same, whether the walls were forced outwards or inwards, both would, *cæteris paribus*, be bowed alike. From the nature of the quoin bond of masonry, however, the end walls at the quoins offer much less resistance to the wall  $c e$ , being forced

outwards, than they do to the wall  $hk$ , being forced inwards, the quoin stones bonded into both walls finding a better fulcrum in the transverse resistance of the end walls in the latter case. The wall  $ce$  in some degree resembles a beam merely *supported* at the two ends, while that  $hk$  is partially in the condition of one *encastré* at both ends, both being subjected to transverse strains; and accordingly the latter usually presents the characteristic curve of double curvature when looked at in plan upon top, as in Fig. 29.

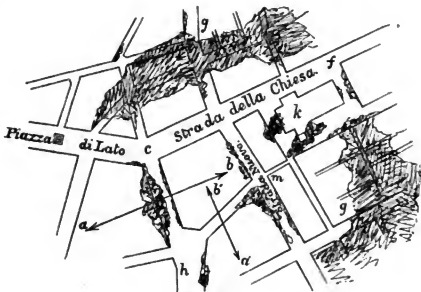
Fig. 65.

of the principal phenomena may be best illustrated by reference to Fig. 65, an imaginary block plan, of part of an earthquake-shaken town. Whole districts at *q q* are prostrated. At both ends of the great church, and about *m*, and along the street from *h* to *e*, houses have fallen, and others are grievously injured; yet these are perhaps amongst the best built and least ancient houses in the place. Passing along the main central street, after debouching over heaps of stone at *e*, it is found, that along the greater part of its length, fissures here and there, a few chimneys, or a side wall down, as we look up some "*vico*," are all the signs of earthquake visible.

The great church, when examined, tells us that the horizontal direction of shock was from *a* to *b*. Returning now over the ground, and examining the place with the compass in hand, we find that the main street presented *its length* to the direction of movement; its stiff front and rere walls, its multiplied floors, have saved it. The street *e* to *h*, on the contrary, although of houses of the same date, height, and character, &c., is nearly destroyed; it was nearly *transverse* to the line of movement. The street at *m* has escaped much better, though much injured, yet it is nearly parallel with *eh*, and the houses are as high if not higher; but we find they are some of the *newest and best-built* houses in the town. Some houses at the right of the Chiesa Madre are thrown down, but no others in the Piazza, have suffered. The rubbish has probably all been cleared from the Piazza in the market-place, and we cannot tell which way the houses fell, but we look at the fallen apse or campanile or transept, and find that it fell against one of these, and upon these houses. We now get out of the highways of

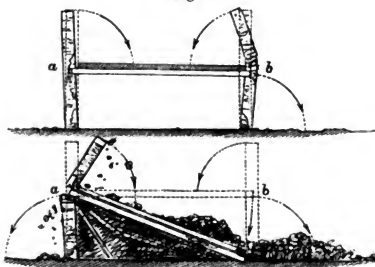
Fig. 77.

certain, if of any considerable magnitude, to bring down the end wall, upon which it strikes with the power of a "battering ram."

it falls, likewise, very commonly outwardly, but, by possibility, in the direction towards the floor also. This chain of events, one of the most potent in the destruction of domestic buildings in Italy by earthquakes, is illustrated in Figs. 76, 77.

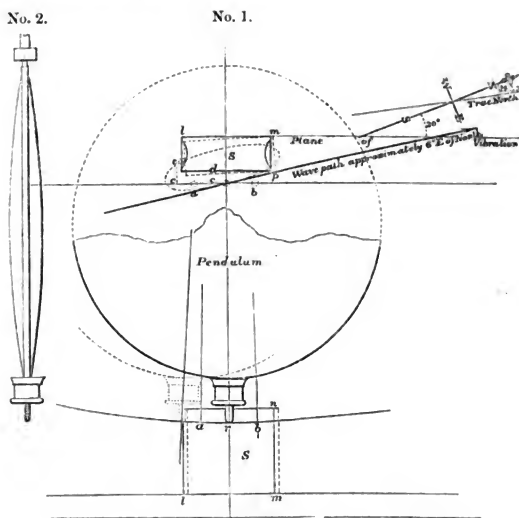
On the morning of the 17th December, 1857, Signor Fiodo found this clock stopped, and the screw of the pendulum in contact with the south end of the steel block,

which had been shifted from its place by the momentum of the pendulum, as in Fig. 115.

I shall recur to the inferences derivable from this in Part III. It is sufficient here to remark that the direction of wave movement indicated is one approximately  $6^{\circ}$  E. of N. The clock was going (*tempo meridiano*) or solar time for Naples, and was on the evening of the 16th December true to time within an error of 0.5 second. It had been stopped at  $10^h 13' 26''$  P.M., which was therefore the time of the first shock at Naples, within less than half a second the error of the clock (slow), + the minute fraction of time due to the increased semi-arc of vibration.

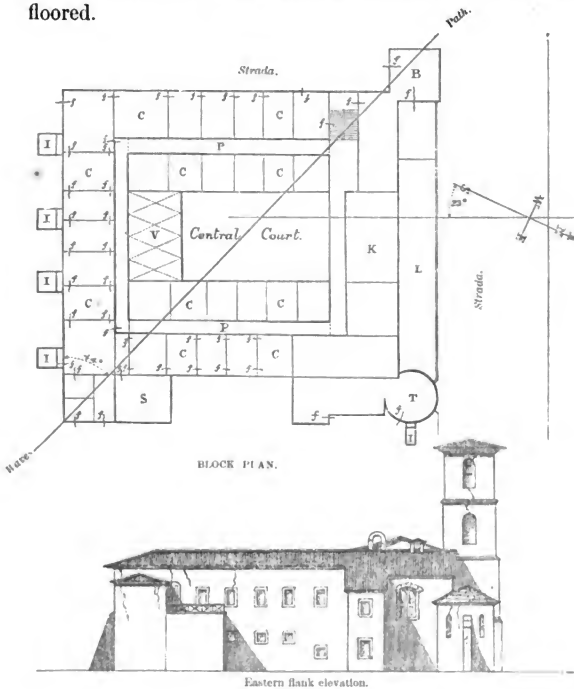
EAST FLANK, EBOLI.

WEST FLANK, EBOLI.

None of the photographs (Figs. 124, 125, 126, Coll. Roy. Soc.), were taken sufficiently near, unfortunately, to show with distinctness any external fissures in this building, nor to show the S. W. angle at all. Referring to the block plan and elevation (Fig. 127), however, some large fissures in the external walls of the projecting buildings over the terrace, and, generally, in that portion of the structure, give an angle of slope with the vertical  $= 15^\circ$  to  $16^\circ$ , and allowing for the change due to the ordinal of the building, indicate an angle of emergence for the wave-path  $e = 18^\circ$  from the E.

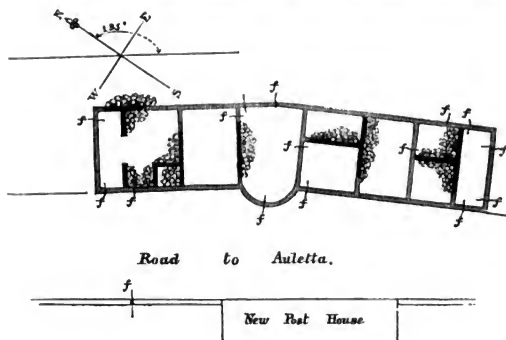
Fig. 128.

The place was damaged by the earthquake of 1783, and rendered uninhabitable by that of 1851. Its general length bears  $135^\circ$  E. of N. The fractures and fissures produced in December are clear and distinct from the old ones. In the sketch (Fig. 128), the portions coloured black indicate the

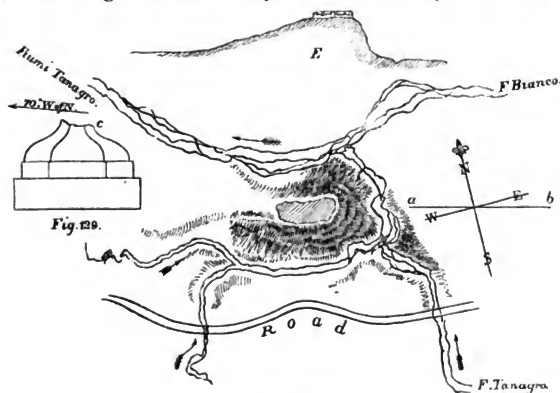
Fig. 130.

As I move round the base of the rock, I can see thus much reason for its comparative security, that the mass of solid limestone upon which it rests, presents its long way to the length of the valley, and lies nearly E. and W.,

with its steep end towards the east, and buttressed away to the westward by a longer slope, as in the section E (Fig. 130) taken in a line with *a b*.

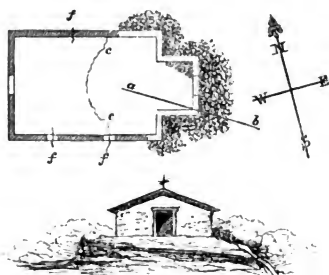
Fig. 131.

This church is a poor building, the walls about 15 feet high and  $2\frac{1}{2}$  feet in thickness, of coarse limestone rubble, covered with a heavy tiled roof upon gross, ill-framed timber. The north wall had, in part, long leaned outwards (as I was informed by the priest), and a portion had fallen towards the north; but all the remainder of the east end had fallen outwards, or in a general direction of the line *a* to *b* (Fig. 131), and a much larger portion of the roof, as indicated by the irregular line *c c*, had come down and fallen within the walls. In both the north and south walls were some fissures *f f f*, which, together with the general direction in which the mass of dislodged material had been thrown, indicated a wave-path of from  $80^{\circ} 30'$  W. of N. to nearly due W. and E. The mode in which the roof

had come down, seemed to indicate a considerable amount of emergence in the wave-path, from the eastward, but

how much, neither it, nor the direction of the fissures, in the coarse rubble, and through the heads of the windows, would indicate.

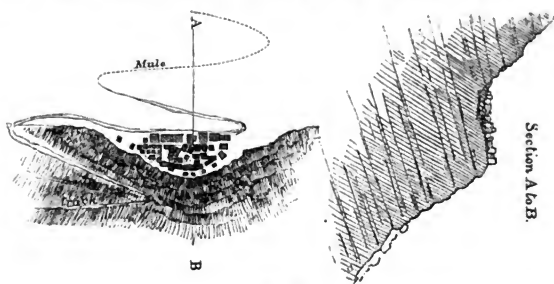
Fig. 137.

in Fig. 137, which dip pretty sharply to the south. I find upon inquiry here that Petina, which is just five

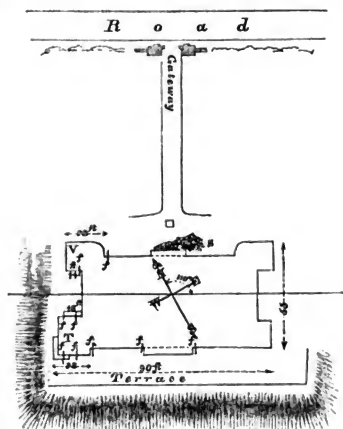
Fig. 139.

The only fissures are those marked *ff*, &c., in the west end, all in the ancient towers, and two fractures in the slender brickwork of the southern arcades. The towers have been thrown westward, off from the body of the building, and the fissures at the reënterant quoins are  $2\frac{1}{2}$  inches open at top, and run nearly from top to bottom of the walls, which are about 32 feet in height to the eaves, and the whole of the west end is out of plumb. The fissures in the south front are seen in Photog. No. 137. Their direction has been determined and limited at the quoin, by the form of the buttress built into it, for nearly

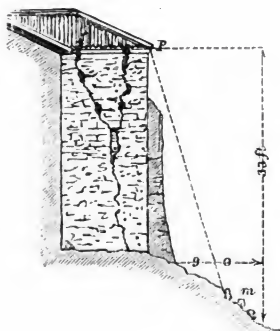
Fig. 140.

The fissures at the internal flanks of the tower, that, T, (ground plan, Fig. 139), looking south, and that, V, looking north, are pretty exactly sketched in Figs. 140 and 141.

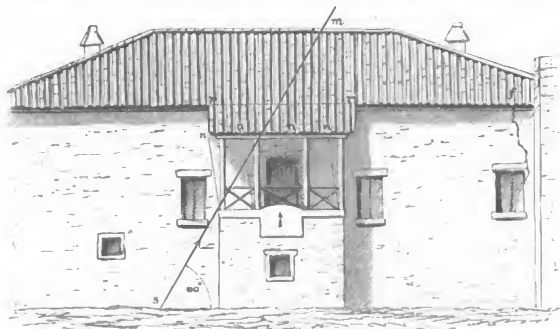
Fig. 142.

(which corresponds to that above the "Portone" of the south front) stood, before the earthquake, a wooden sort of verandah, framed, as shown in Fig. 142, and covered by a

prolongation of the slope of tiling of the roof. The whole of this had been thrown down, and was lying on the ground at and about the point *s* (in Figs. 139, 142, and Photog. No. 138) in dislocated fragments, from which, collecting and laying together the timber-work, I was able to reconstruct the design of the fabric.

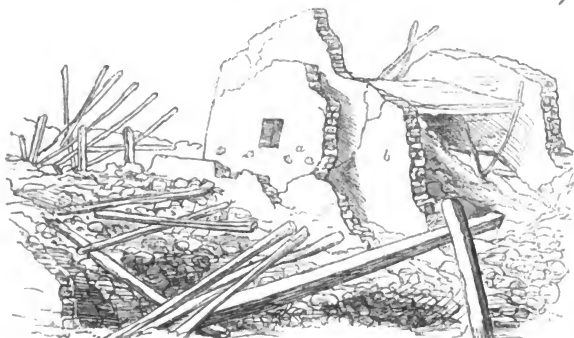
Fig. 152.

a certain range nearly cardinal. The walls *a* and *b*, and all parallel to them, run nearly E. and W. These were in great part, more or less standing, but fissured, in sloping cracks; but the walls whose plane had been N. and S.

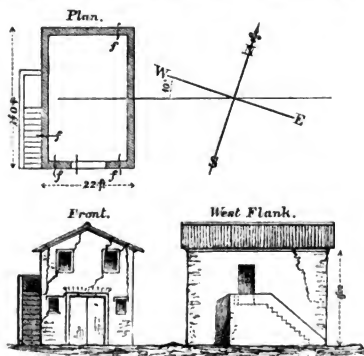
Fig. 153.

Descending with Padre Mancini, from the town to the road at the valley bottom, which is perhaps 100 feet above the bed of the Tanagro close beneath, I examined the little Casa Comunale, a nearly new building (about three years old) a parallelogram of two stories (Fig. 153), nearly

cardinal (axial line  $10^{\circ}$  W. of N.), built of good rubble, with cut stone jamb dressings, and middling quoin stones, and with a heavy external stone staircase on the west flank. It was fissured in several places, and the fractures gave a wave-path of  $120^{\circ}$  W. of N., and an emergence of about  $65^{\circ}$  with the horizon. The emergence might be steeper, however, as the direction of the fissures in the front, had been coerced in some degree, by the large proportionate surface, of cut stone jamb dressings.

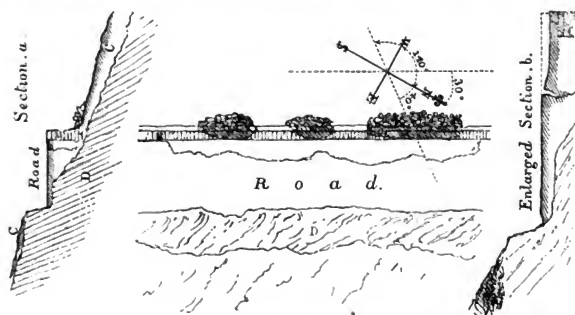
The form of the fissure and section of the road, as sketched, are shown in Fig. 157. Three portions of the revetment

had been thrown towards the west, and from the position of the fallen material, the direction of the wave-path proved to have been N.  $140^{\circ}$  W. The portion of the road to the west of the fissure, had *slipped and descended* about 4 to 6 inches below the former level, as shown in section *b*. It was impossible to tell, whether the revetment wall had been founded upon the rock or not, but from the appearance of the ground at its base to the westward, I believed it had not: in any case, it had gone out at the base, towards the west, and with the mass of earth behind, had been severed from the remainder of the road filling, and slipped at the same moment. It is a case very analogous to the Auletta fissures, with this difference, that here, from the unsupported position of the road embankment and revetment, and the direction of the shock, the separation had much more nearly approached a "throw off" *at the instant* of shock, mixed with the movement of slip or descent.

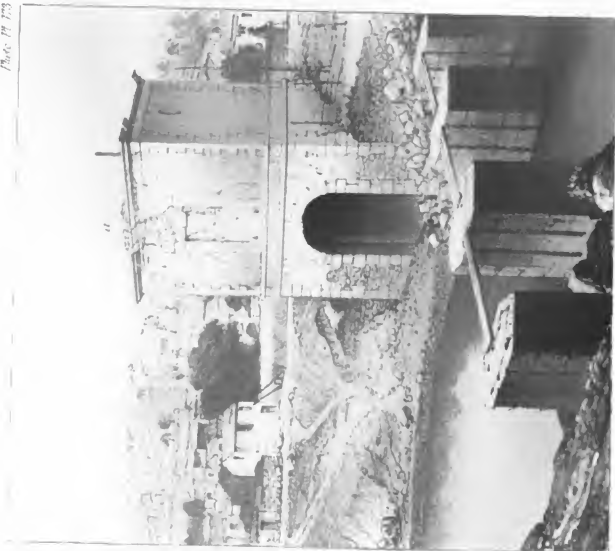
Photog. No. 170 presents an arched wall in a north and

south plane,  $20^{\circ}$  E. of north, in the same monastery, and an example, of heavy dislocated, and inclined fissures. The average angle here was  $45^{\circ}$  to  $50^{\circ}$  from the horizon. On principles explained in Part I., this is below the actual angle of emergence, as here each pier rocked more or less individually, and with the direction of the voussoir joints tended to give greater perpendicularity to the fissures. The crown of the upper tier of arches had all fallen in, and they, as well as the cross wall seen to the left of the picture broken off, had all been thrown northward, as the marks of abrasion upon the plaster of the face of the arched wall testify.

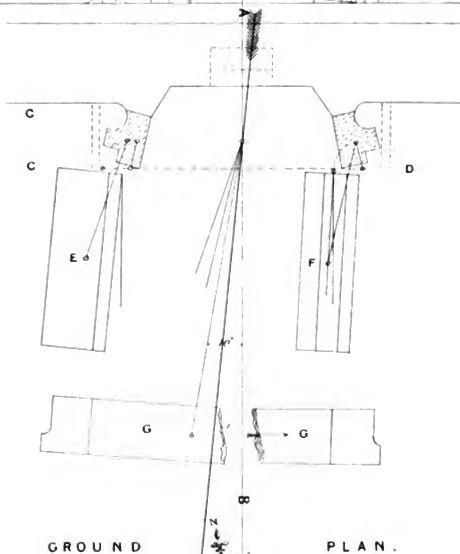
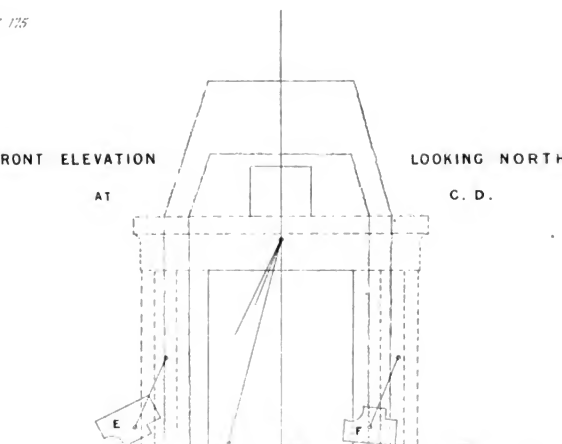
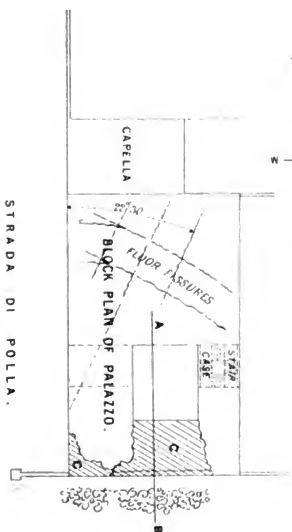
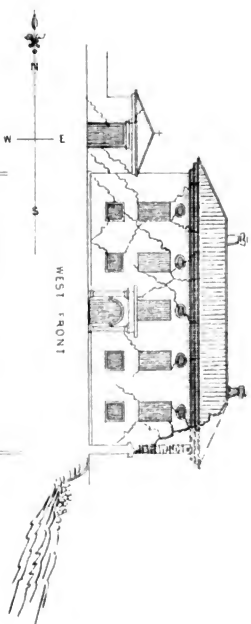
PALAZZO PALMIERI AT POLLA. SKETCH NOT TO SCALE

In Diagram No. 175, Fig. *a*, is a sketch elevation of this west front and block plan of the building. The house is exactly cardinal; it is large, comparatively new, and tolerably well built, though of short lumpy stone, with much cut limestone about the quoins and jambs, &c. It consists of a central court, surrounded by buildings of two stories and an attic, beneath the tiled roof. It is built upon the solid limestone rock, which at this point rises up through the deep alluvium, that lies around it at every side for a considerable distance. The ground is level around it except on the south, where it slopes off rather rapidly, the rock disappearing beneath the alluvium. It is, in fact, built upon the top of a sort of low pinnacle of limestone rock, that comes up (like many others round the borders of the great plain) to its level, through the deep alluvium, so that it stands as it were on the top of a little subterranean "colline," like a rock in an ocean of earth. The beds of the limestone here, as generally throughout the Vallone, are almost vertical, or at extremely sharp dip, and tend to a general east and west direction of strike.

C. C. PART PROSTRATID  
THROWN SOUTH

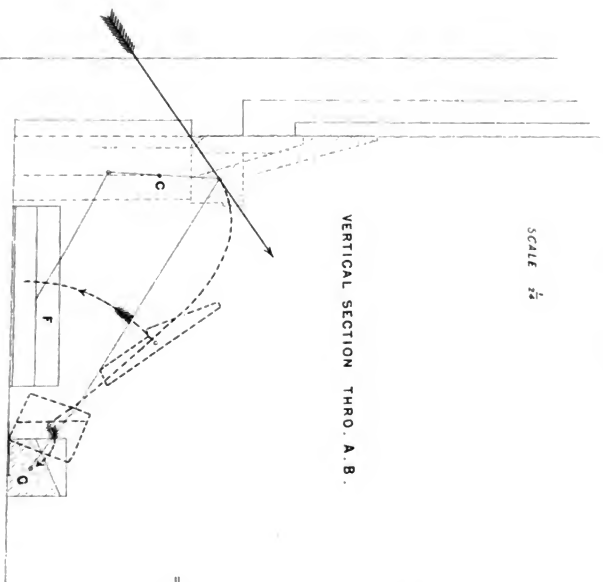
STONE BLOCKS OF THE CAMINE IN KITCHEN. AT  
PALAZZO PALMIERI. THROWN FORWARD.

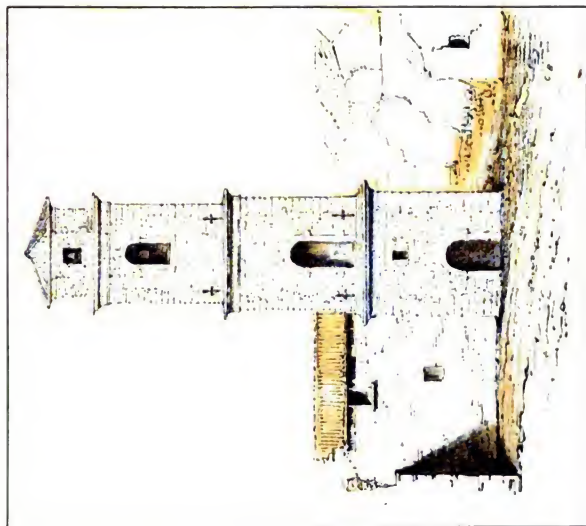
The Photog. No. 189 (Coll. Roy. Soc.) shows the east end of the cathedral church, and various adjoining buildings, looking nearly westward. The general evidence of the wave-path with steep emergence from the north, is observable in the thrown and shattered north and south walls, and in the wedge-like mass, projected from the S. E. quoin of

the chancel, and the roof of it and of the south transept fallen *inwards*. The horizontal direction of wave-path deduced from the thrown quoin, and from the average of five sets of fissures in the church, was  $165^{\circ} 30'$  E. of north, and the angle of emergence  $47^{\circ} 30'$ . The angle of emergence given by thrown quoins in three other buildings (dwelling-houses), of much worse masonry, however, and therefore capable of less exact determination, was only  $39^{\circ} 30'$ . Lower down upon the eastern slope of the town a large heavily built range of building, with front walls to the narrow street  $3\frac{1}{2}$  feet in thickness, running nearly east and west, shows fissures of two inches wide, on the level of the first floor above ground, which indicate a wave-path not far from north and south,  $177^{\circ} 50'$  E., the nearest approximation. One of these in the soffit of the arch, over a "portone" leading to a "vicinello" is shown in Sketch Fig. 190, and gave a path exactly north to south. A wall of old and little coherent masonry, has had six feet in height of its upper part thrown off, parting horizontally along, at 38 feet from the base. The mass of material has fallen at an average distance of 20 feet from the base, towards the south, and a point or two towards the west. The angle of emergence deduced from this (the horizontal velocity as at Polla) is between  $45^{\circ}$  and  $50^{\circ}$ , dependent upon the constant adopted for the adherence of the mortar and masonry at the base of separation. The result sufficiently corroborates those above given from more certain data.

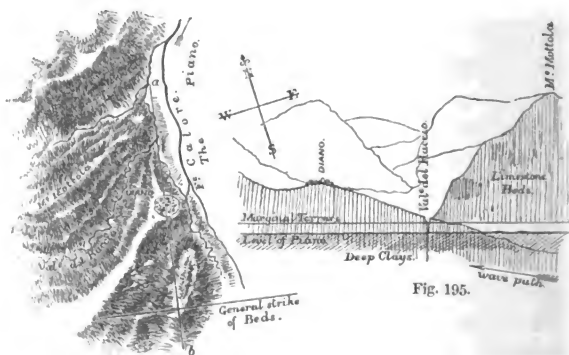
Fig. 194.

The comparative immunity from destruction of Diano, is not difficult to explain. The direction of wave-path was here nearly due north to south. It therefore passed from the deep clays of the piano into the long spur or colline of the town, end on, (see Sketch Nos. 194, 195,) losing a large portion of

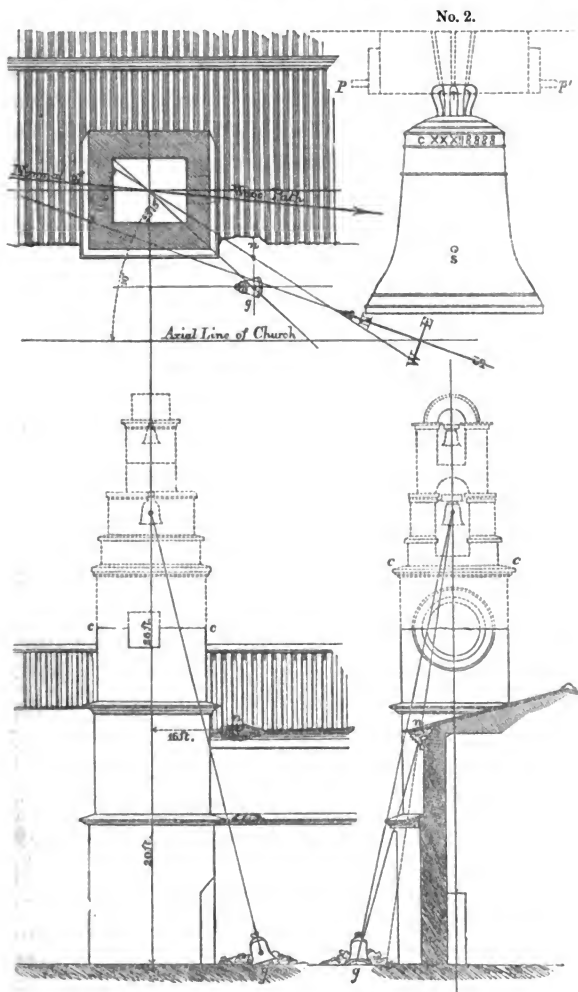
The church of La Sala, like numbers of others in Southern Italy, has been built, not in accordance with ecclesiastical notions, but to suit the lie of the ground. Its axial line is  $20^{\circ}$  W. of north, and it has a campanile, rectangular in plan, external to one flank wall, as in diagram Fig. 206. The upper part of this, previous to the earthquake, carried two bells, hung between the jambs of piers and arches on top. These were overthrown, down to the level of *cc* by

the shock, and the tower has since been taken down, to the level of the centre of the mock clock dial. By careful measurements of the standing portion, and by comparison of the taken down pieces, with the sketches and description of the Sotto Intendente, I was able to restore the design of the superstructure, and obtain a close approximation to its original height. Both bells oscillated in a plane, parallel to the axial line of the church. At the shock, whose wave-path passed obliquely through the open arches on the summit of the campanile, the jambs or side piers separated enough from each other, to permit the bells to be released from their pintles, and these were thrown to the ground, in the direction shown in Fig. 206. The larger bell remained unbroken, having fallen amidst some rubbish on the ground; the smaller was destroyed, having descended from a greater height and fallen on hard ground. The piers did not come down at once with the bells, but fell shortly after. The place where the smaller bell struck the ground, could not be ascertained with certainty, but the Padre, the Sotto Intendente, and others, were agreed upon, and pointed out precisely, the spot where the large bell had alighted; and its path of descent was also indicated by the breaches, which it had made in falling, in the eave tiles of the roof, and in those of a string course of the external flank wall of the church, near the campanile. The bell itself had been removed into the church (but the fallen rubbish was still on the ground): it is very antique and remarkable for its form, and is correctly sketched in Fig. 206, No. 2. It bears an inscription in Lombardic (?) characters, and a date which I presume to be 1324 or 1336. The Padre, who is accustomed to judge of the weight of bells,

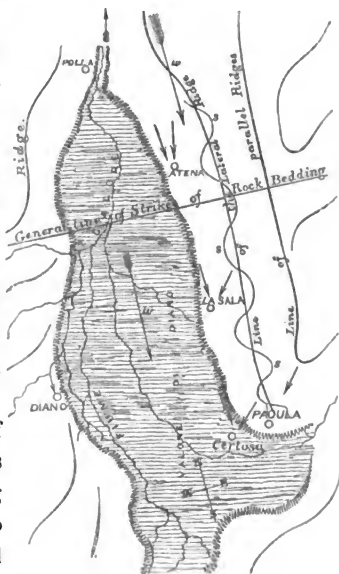
Fig. 208.

Referring to Fig. 208, in which is sketched the general form of the piano, and the prevailing lines of ridge, or summits of the mountain ranges around it are marked by

dark lines; the main direction of the wave-path from Campostrina southwards is indicated by the large arrows *w*, *w*, and is that given generally by everything in the piano, south of Polla,

to Padula. But on the east side of the valley, going southward, it is constantly disturbed by the intermixture of another wave-path oblique to the former, and with increasing obliquity the further we go south; this intersecting angle, being small at Atena, greater at La Sala, and greater still at Padula, and the direction of wave transit of this secondary shock being always from N.E. to S.W., or from the lateral chain to the east of the valley.

It is obvious that the impulse given at the north end of the valley in a north to south direction, simultaneously to the deep clays of the piano, and to the eastern mountain range at its north end, was transmitted comparatively undisturbed as to direction through the former; but, in passing along the lateral ridge of limestone mountain across all the nearly vertical beds, transverse vibration was produced along

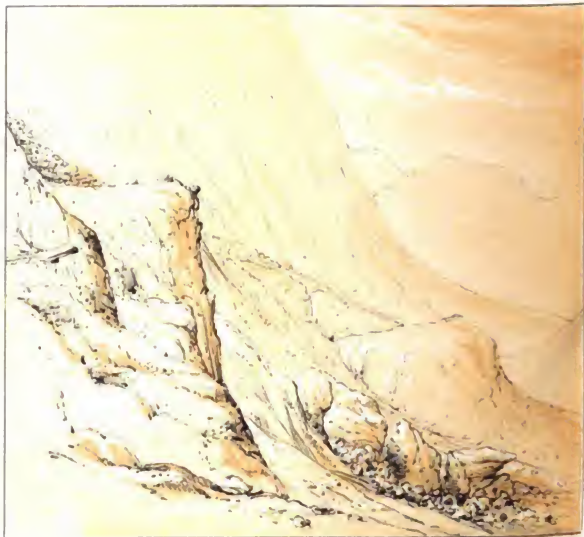
The Photog. No. 210, is taken in this valley, looking back at the town toward the S.W. On the steep counter-scarp to the right of this view I found a large fissure in the solid clay covering, extending some 300 yards in length at about 270 feet above the bottom of the gorge. The direction was due E. and W. by compass, and its S. slip was from 1 to 7 inches below the level of the opposite one. The fissure is a flowing curve similar in horizontal plan to the contour of the hill side, and its line of direction is just that most favourable, to a throw off and slip of the clay masses, upon the sublying rock, by the jog of the earthquake, which is unquestionably the nature of its formation. Upon the opposite side, and about half a mile up the valley to the north, where the east slope has become much steeper, I observe with the telescope that huge masses of clay and gravel that had stood above the torrent as nearly vertical banks, of from 50 to 120 feet in height over the water, have in several places been shaken down, and fallen in great masses, damming the torrent into large and very deep, discoloured pools, from some of which the dams have already given way by little debacles, while in several of the others, the water is escaping beneath and through the clay, and carrying volumes of fluid mud and sand away

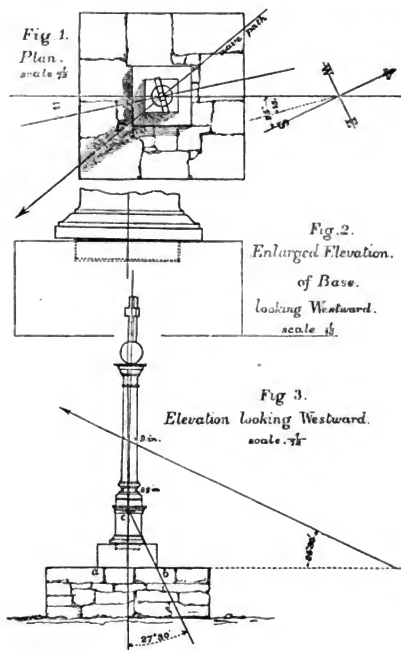
Fig. 216.

cross, and placed upon a square pedestal and plinth block, elevated on a few courses of rude masonry as in Photog. No. 215 (Coll. Roy. Soc.), and Figs. 1, 2, and 3, Diagram No. 216. The ball and cross are secured to the top of the column, only by an iron dowel, and are loose; the plane of

the cross has been long twisted out of square, I was informed.

as in Fig. 2, and jammed quite close to the plinth block at the opposite or north side. The shaft, pedestal, and plinth are socketed into each other, as shown, without cement.

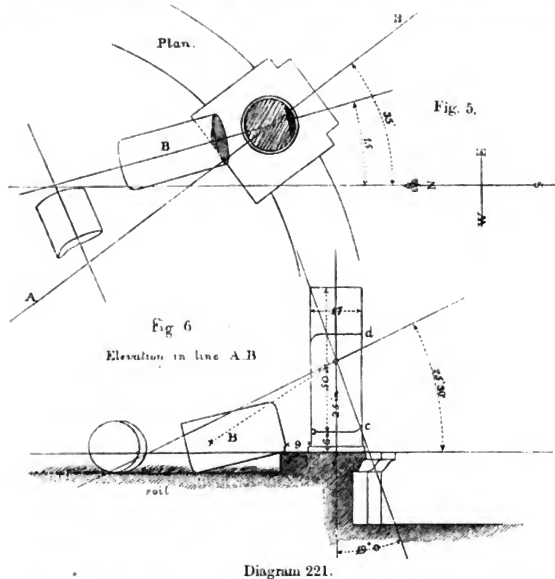
Diagram 221.

The columns had all been originally formed of an artificial "beton" or concrete, of broken limestone and brick, and lime mortar, rudely formed enough, without any base moulding but a fillet, and were 17 inches diameter. They stood upon the top course of a continuous base of limestone, running round a large circular raised platform of earth. They had all been broken down and the shafts had disappeared to within a few inches of their bases years since, except this one portion of a shaft, which stood before the earthquake 4 feet 8 inches above its base. For 6 inches in height the shaft was a united block, and fast to the stone base; at this height an old fracture had existed, and a portion of shaft, 2 feet 10 inches in length, had stood upon the lower block, having been replaced upon it, and a little fine mortar interposed in the old fracture. In toppling over, at the north side of the column, the arris was broken out, and the diameter in N. and S. direction reduced to  $15\frac{1}{2}$  inches, as shown in Figs. 5 and 6, Diagram No. 221. Upon the

been overthrown by the shock, and lay as in Figs. 5 and 6, Diagram 221, and as shown in Photog. No. 217, having never been moved or meddled with, the garden being an enclosure, since the earthquake. The lower and longer block was, at its lower end, within 9 inches of the stump of the shaft. The top block had been thrown over along with the one below it, had separated on striking the ground, at the top part, as the position of the other piece and the lower level of the soil than the stone base (Fig. 6) proved, and had slewed round and rolled a little off. The longer piece remained

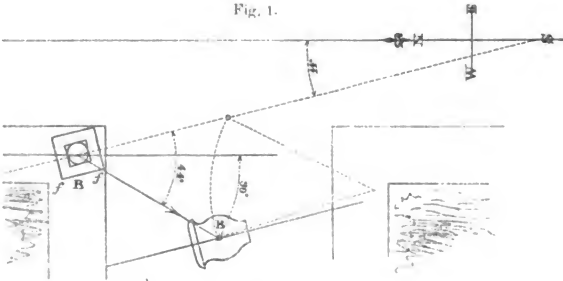
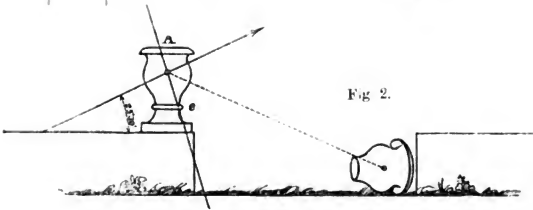
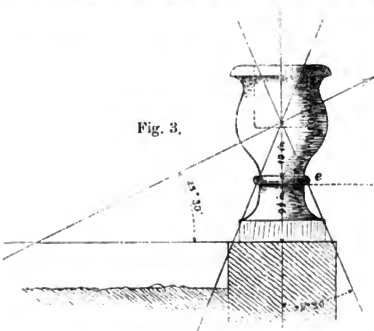
Diagram 222.

level and smooth, and the arrises perfect; and the upper and lower parts had been merely laid together, without any cementing material.

It will be seen, on looking at Fig. 3 (Diagram No. 222), that the vase might have been thus tilted upon its own base at the joint *e*, to the extent of nearly  $22^{\circ} 30'$ , before it would have lost the power of recovering its position, and that when tilted through part of this angle, the effect of the throw of the second shock delivered to it through the base, would tend to increase the rotation commenced, as well as to diminish the extent of horizontal range, or velocity impressed.

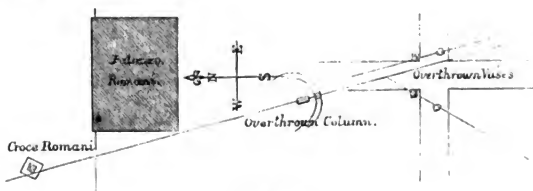
The general relation of all these objects as to azimuth, is shown in Fig. 223.

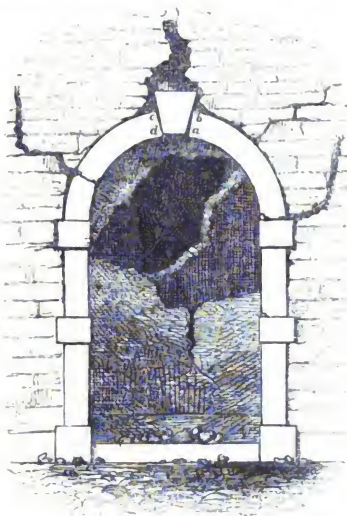
Fig. 224.

I found here also, as at Polla, an example of that singular circumstance, the keystone or block, of a cut stone semicircular arch over a doorway, which had *worked up* in place of coming down (by the movements of the earthquake) between the remaining arch stones. This case, of which the (original) Sketch No. 224 is a true representation, (though very imperfectly given by the woodcut,) is obviously due to the rocking to and fro of the whole wall in the plane of the arch, the motion being several times repeated, and hence the alternate partial freeing and gripping of the keystone, at *a* and *c*, *b* and *d*, between the rocking voussoirs, which, moving on the lowest point of the jambs, or at the springing level, are thus at each oscillation, relatively higher and lower than each other, at *d* and at *a*. The

keystone at each alternation, if already tolerably free above, by the fractures of the wall, produced at the first moment

of shock is thus moved up more or less, and finally remains at the height gained.

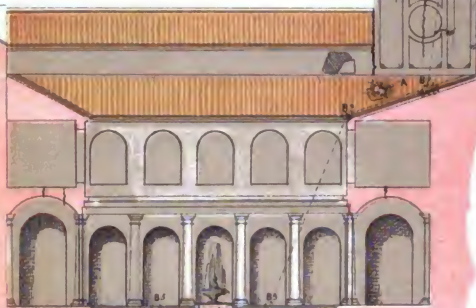
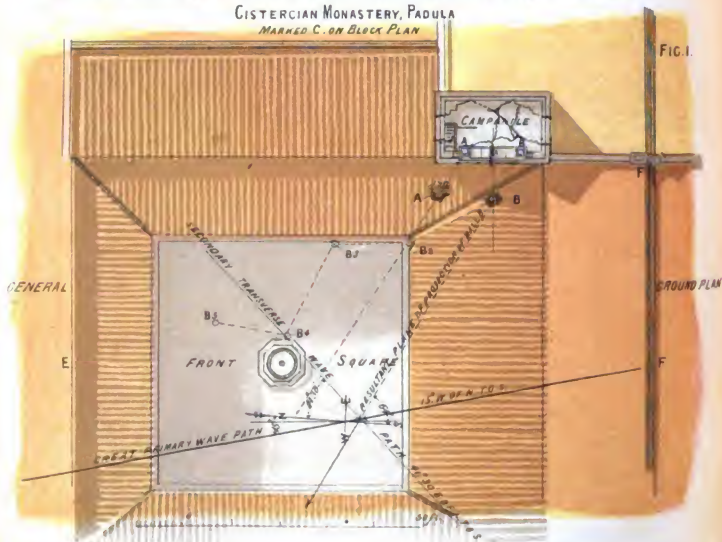
SKETCH OF THE CAMPANILE COURT WITH THE FALLEN BALLS FROM THE CAMPANILE  
CISTERCIAN MONASTERY, PADUA  
MARKED C. ON BLOCK PLAN

FALLEN A B ROLLED

tion as the hands of a watch move. Some of its smaller are thrown down.

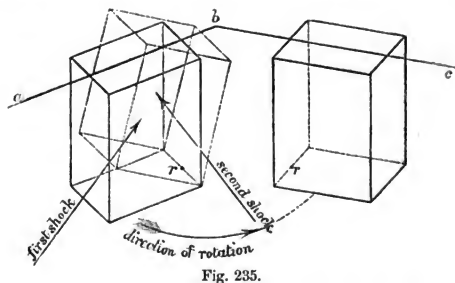
Fig. 235.

Fig. 235 shows the action of any double shock ; Fig. 236 the variations of result produced, first, by rotation in the first

Applying this to the facts at the monument of St. Bruno. All the finials, &c., are twisted from left to right; we know that the main shock was from  $15^{\circ}$  W. of north to the south, it therefore follows, that the shock which first moved them, arrived in a path somewhere between that, and from east to west: by this they were *tilted*; by the immediately following shock,  $15^{\circ}$  W. of north to south they were *twisted*. Neither shock was sufficient, in velocity or range, completely to overthrow any of them, except those which were top-heavy, by having had balls at their summits, which have, except in one instance, been all dislodged.

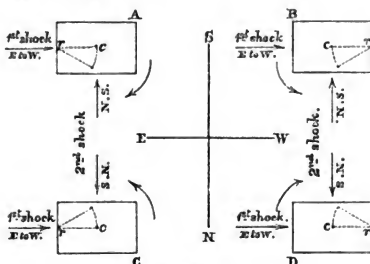
Fig. 236.

semiphase A, and second semiphase B, by the same double shock; secondly, the like by rotation, in the first semiphase (C), the first shock being as before, but the second, contrary in direction to that of the previous cases (A and B), and the like for the second semiphase (D), the two shocks being the same (C and D).
